International Carwash Association
Serving the Professional Car Care Industry

Mercedes-Benz Tele Aid Antenna

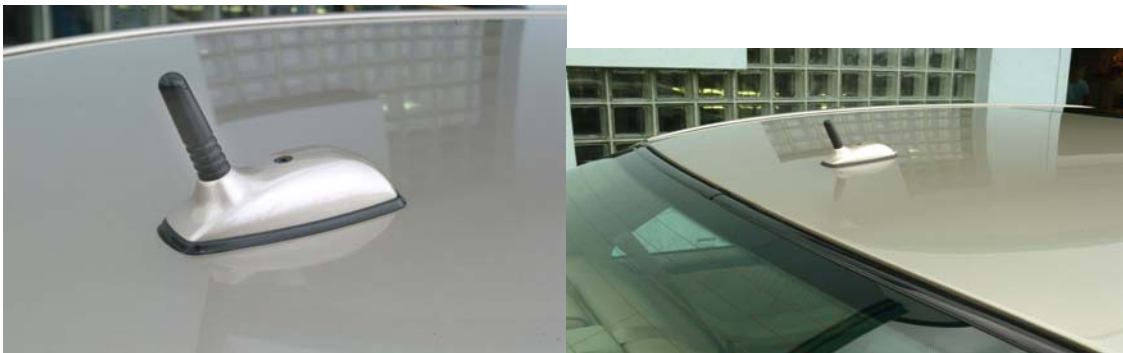
The Mercedes-Benz vehicles equipment with the Tele Aid Communications System has a short antenna located near the rear of the roof. The flexible antenna has a wire located in the center which can be bent rearward as the vehicle proceeds through a car wash by the overhead mitters.

This repeated bending of the wire in the antenna can eventually lead to breakage. The repair cost to replace the Tele Aid antenna is approximately \$400. Mercedes-Benz has been contacted regarding this issue and they claim it is not a design problem and they will not cover the cost of replacement.

As a result, it is suggested that car wash owner/operators alert Mercedes-Benz owners with the Tele Aid option that there is a risk of antenna damage before they enter the car wash. These pictures are good education tools for your employees and customers that this problem could occur.
